- Property Inspection Report -

Nowhere In Particular, Every Town, CO
Inspection prepared for: Client
Date of Inspection: 3/1/2017 Size: 1,285 SQ FT
Weather: Clear

Inspector: Charles (Chet) DeLarm
ASHI Member # 262733
924 East Dale Street, Colorado Springs, CO 80903
Phone: 719.217.4407
Email: safeguardinspects@gmail.com
SafeguardInspects.com

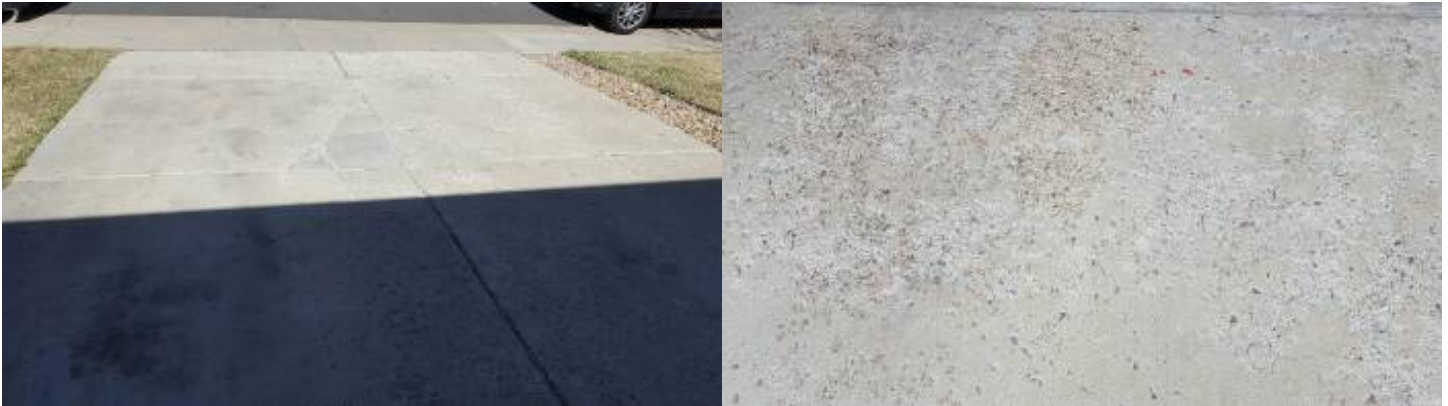
There are areas of spalling present. Spalling is when the top layer of cement breaks loose leaving exposed aggregate exposed. Although unsightly, the functionality of the concrete is not affected. I have yet to find a product that will correct the situation over the long term.

Excessive cracking was observed at the concrete driveway. I recommend filling any cracks in excess of 1/8" to prevent water from entering the area and causing additional damages. Due to the size of the cracks, filling them may not be an option. A qualified concrete contractor can make the needed repairs.

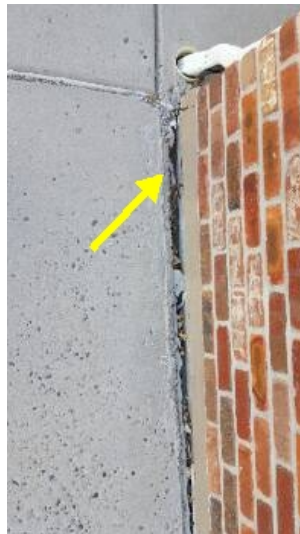
There are areas of spalling present. Spalling is when the top layer of cement breaks loose leaving exposed aggregate exposed. Although unsightly, the functionality of the concrete is not affected. I have yet to find a product that will correct the situation over the long term.

A crack is present where the walkway meets the house. This is quite common. I recommend filling all cracks greater than 1/8" to prevent water intrusion.

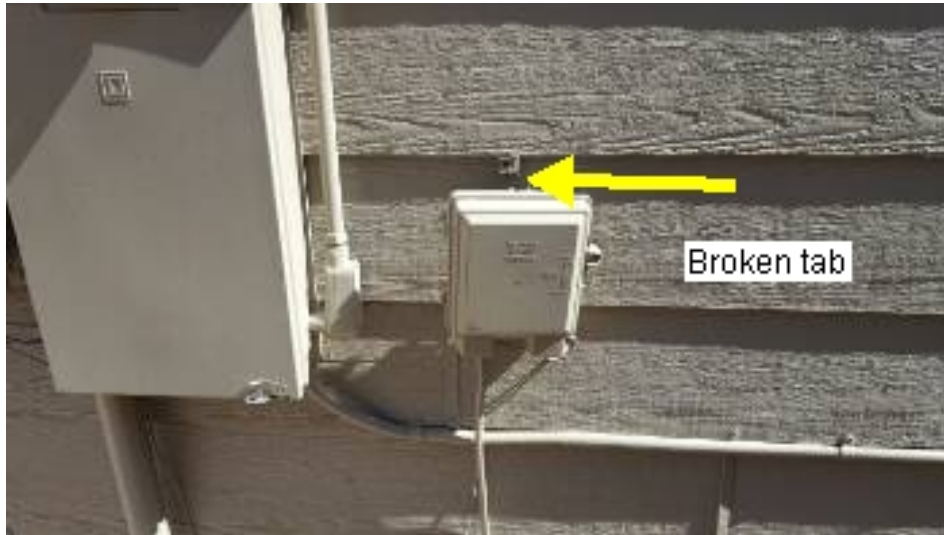
W side

The exterior outlet cover is broken at front door. This is a safety concern. I recommend an approved waterproof cover be installed on all exterior outlets.

Phone network box broken and coming away from the house

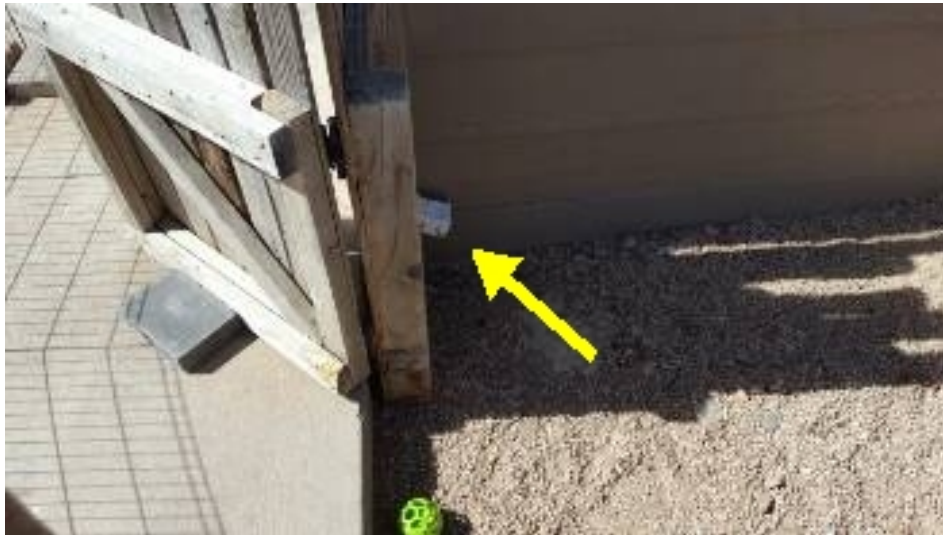
SW corner

There is no downspout discharge at several locations. Potential water intrusion can occur and foundation damage is possible. I recommend installing a method to discharge water away from the structure at all downspout locations.

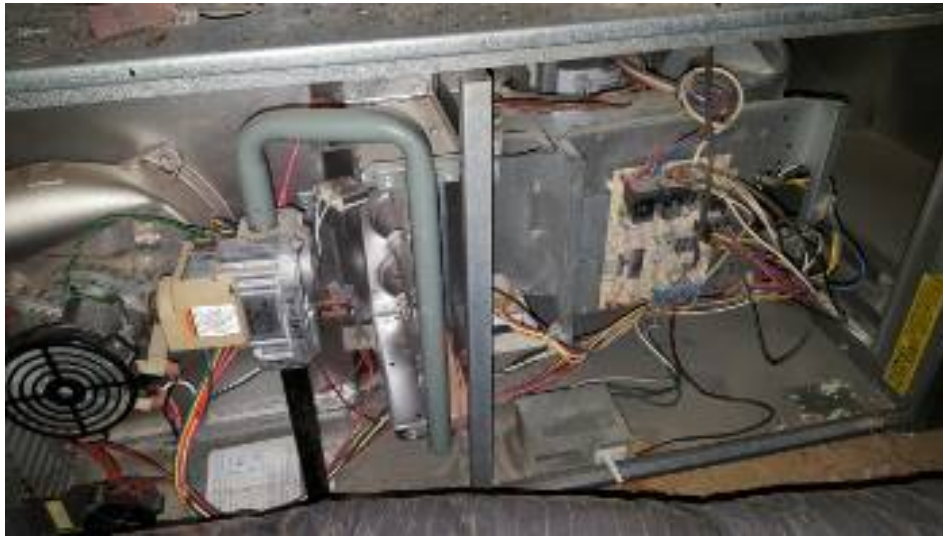
The furnace cabinet was fairly dirty. I recommend cleaning and adjustment by a qualified HVAC person. My inspection does not include evaluation of the heat exchanger, as it is not fully visible. An checkup by a HVAC contractor will allow the inspection of this critical component.

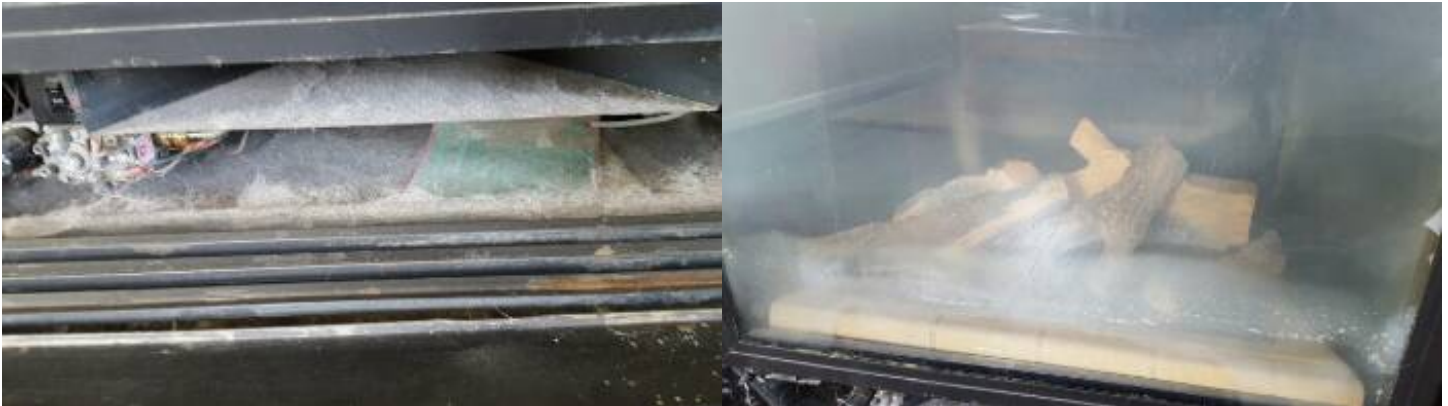
The gas fireplace is dirty. Gas fireplaces should be checked periodically to assure proper function. I recommend a qualified gas fireplace technician inspect and clean the unit to assure it is functioning properly.

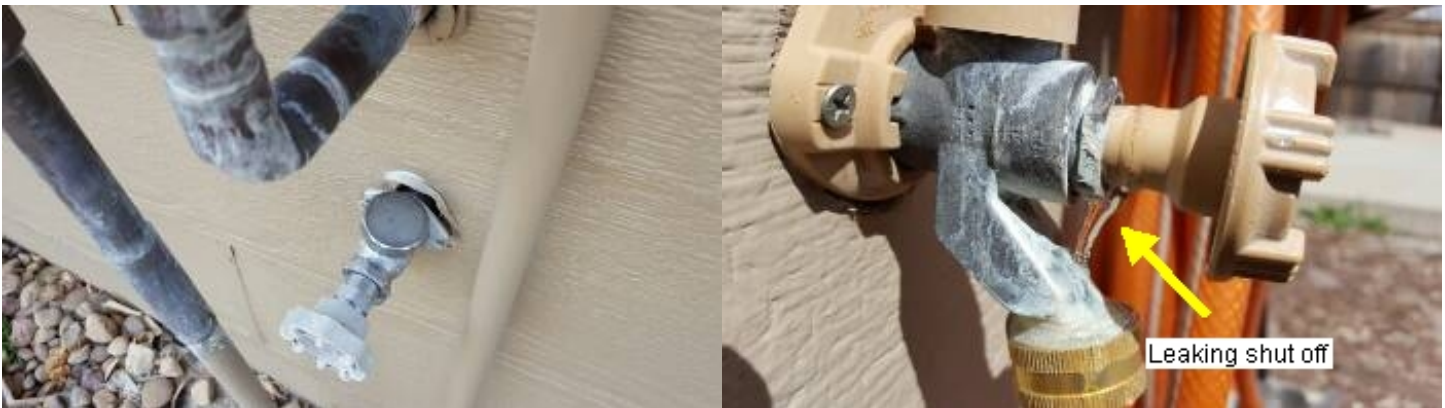
The sillcock on the east side of the home does not turn on. This one is assumed to be tied into the sprinkler system and will be active when the sprinkler system is turned on.

Sillcock on the rear of the house leaks. I recommend a qualified plumber correct this issue.

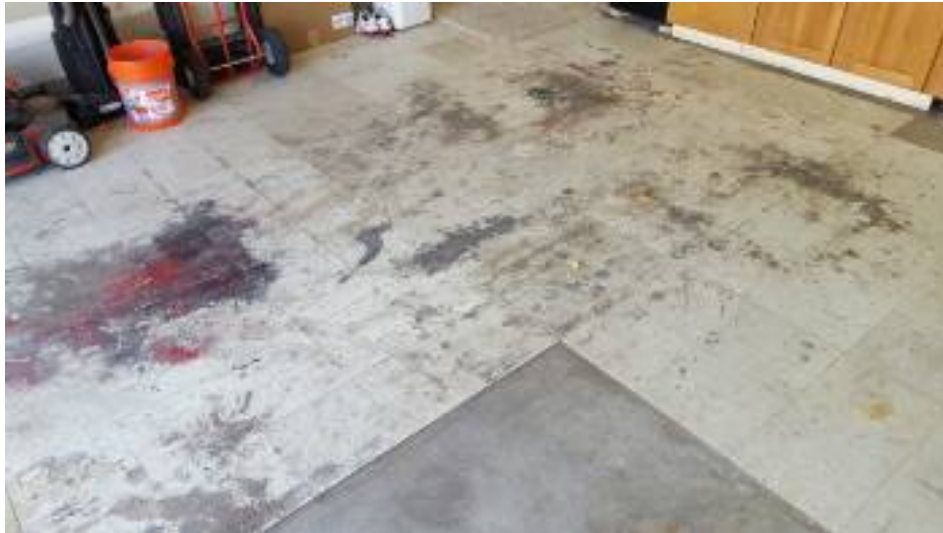
Garage floor

Visible portions of the garage floor appeared sound with no observable cracks, at time of inspection. Entire garage floor is not visible due to installed tiles.

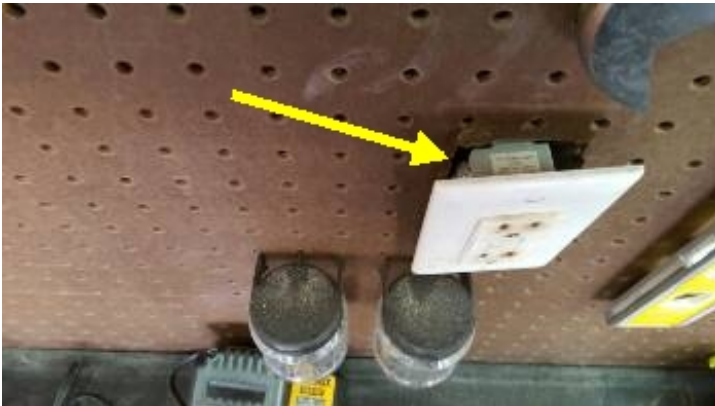
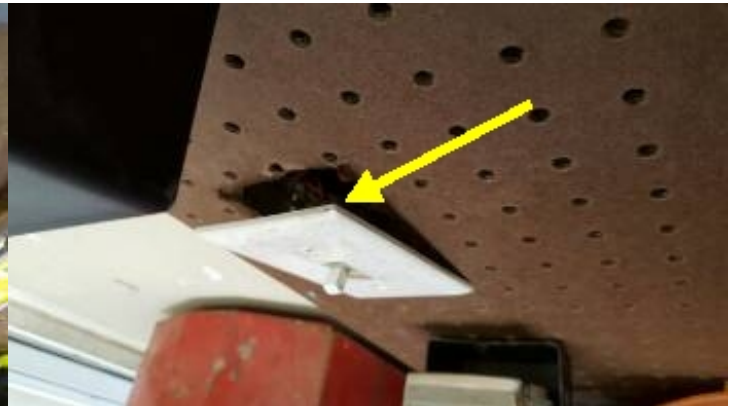
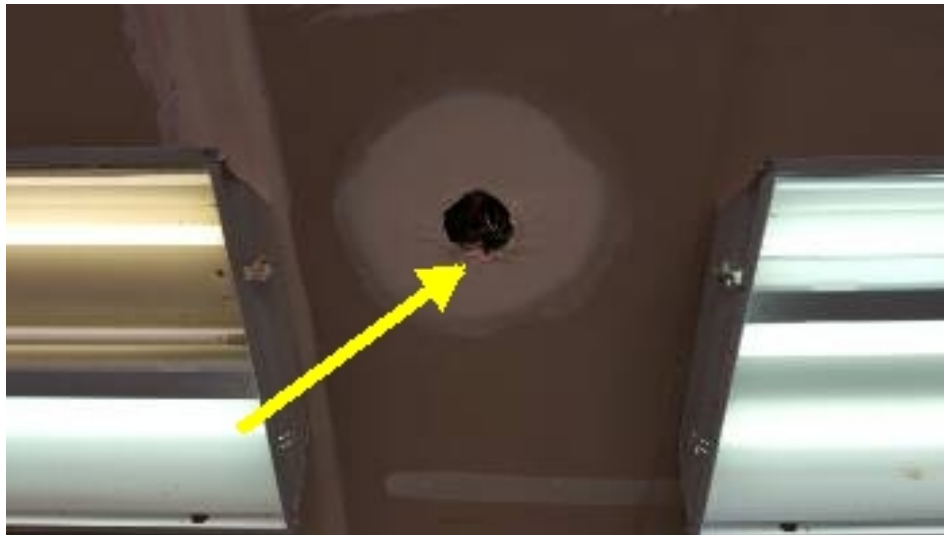
The GFCI in the garage does not function. Recommend that a qualified electrician replace the GFCI.

Switch and GFI both are not attached to the wall. And do not have box extenders installed. Recommend a qualified electrician makes these corrections.

Missing cover plate on ceiling light box. Recommend a qualified electrician makes these corrections.

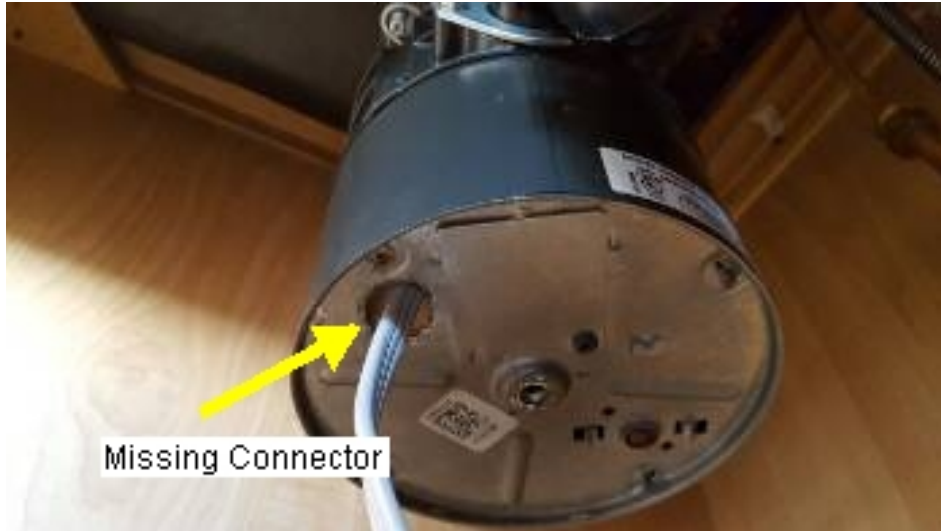
The electric wire for the disposal is missing a wire connector. Wire damage could easily occur. I recommend a qualified electrician make the needed repair.

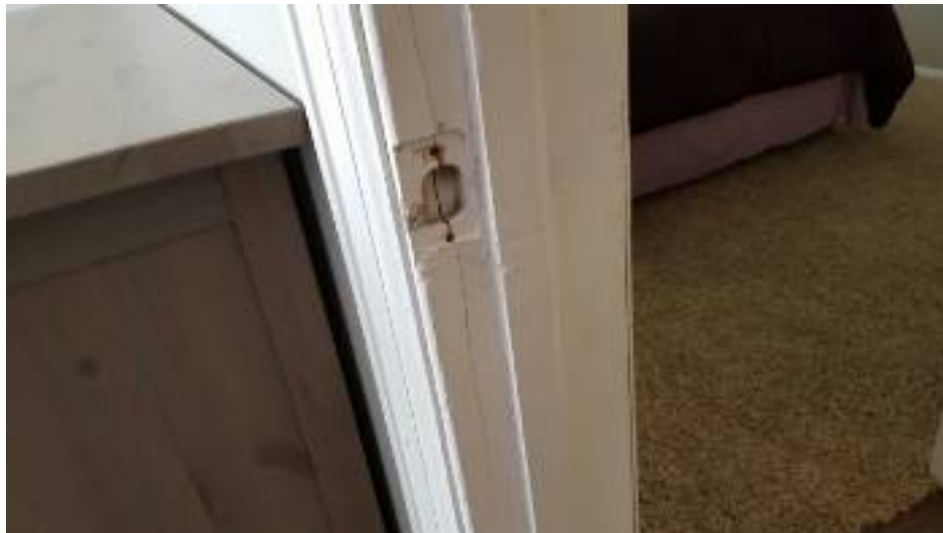
Straight plate missing on master bedroom door.

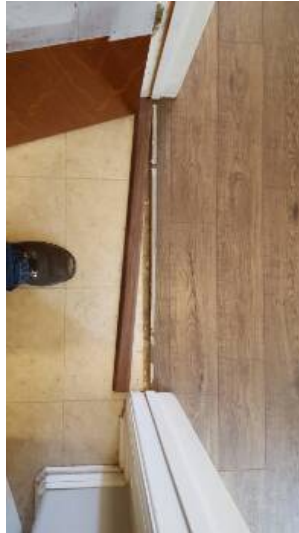
entrance to laundry room

Transition strip on the laundry room door is loose. Recommend proper attachment.

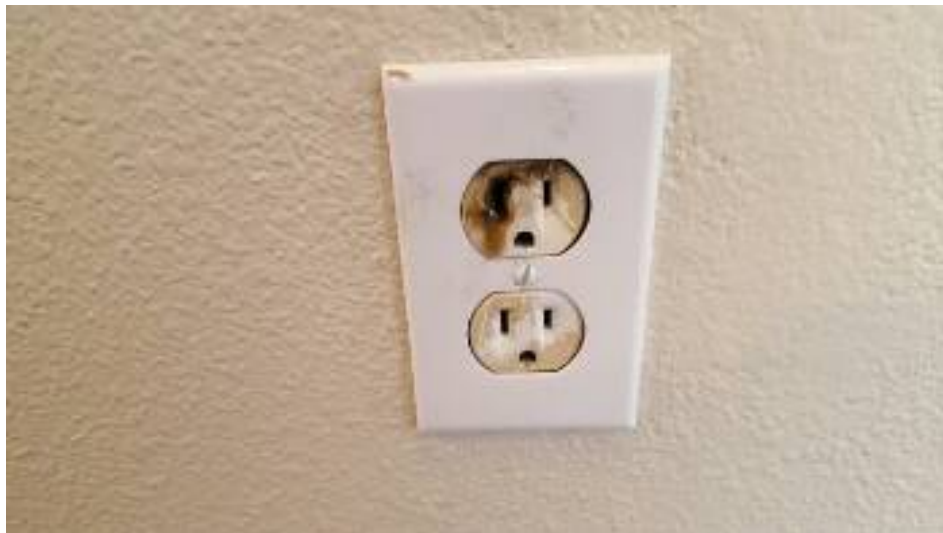
Hallway Outlet

Burned receptacle located in the hallway recommend replacement

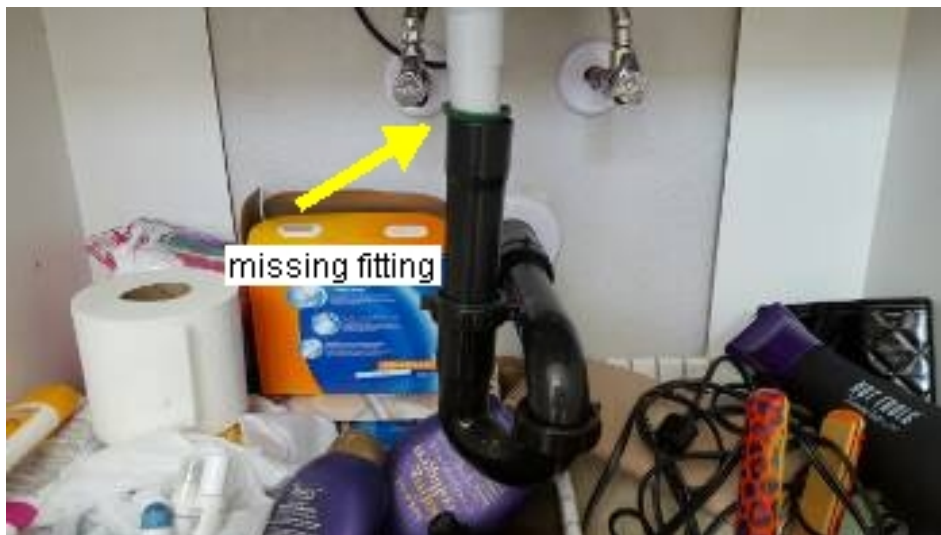
both master bathroom sinks

- Neither vanity sink stopper function. I recommend a qualified plumber correct this issue.
- 1 1/2" tubular piping was used where 1 1/4" tubular piping should be used on the drain lines. The compression fittings between the sink drain and extension pipe is not present. I recommend changing pipe out to correct sizing and using the correct compression fittings. I recommend a qualified plumber correct this issue.
- The compression fittings in the waist lines are reversed in multiple fittings. I recommend a qualified plumber correct this issue.

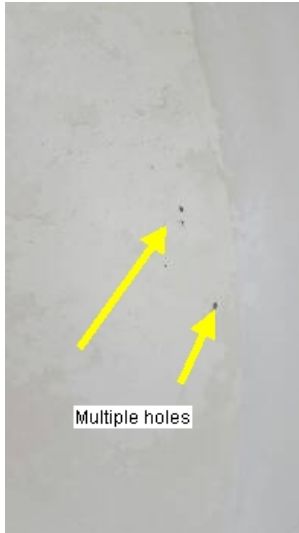
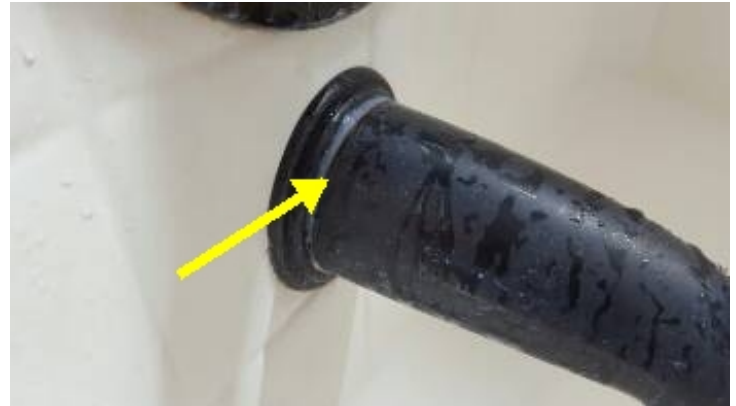
There are several holes in the bottom of the tub that are allowing water past the tub.
 Incorrect installation of tub spout. Recommend qualified plumber reset the spout.
